Fractures in Ground and Damage to Houses in Granada Hills Area of Northridge during by 17 January 1994 Northridge, California, Earthquake Sequence

Compiled by Nils A. Johnson

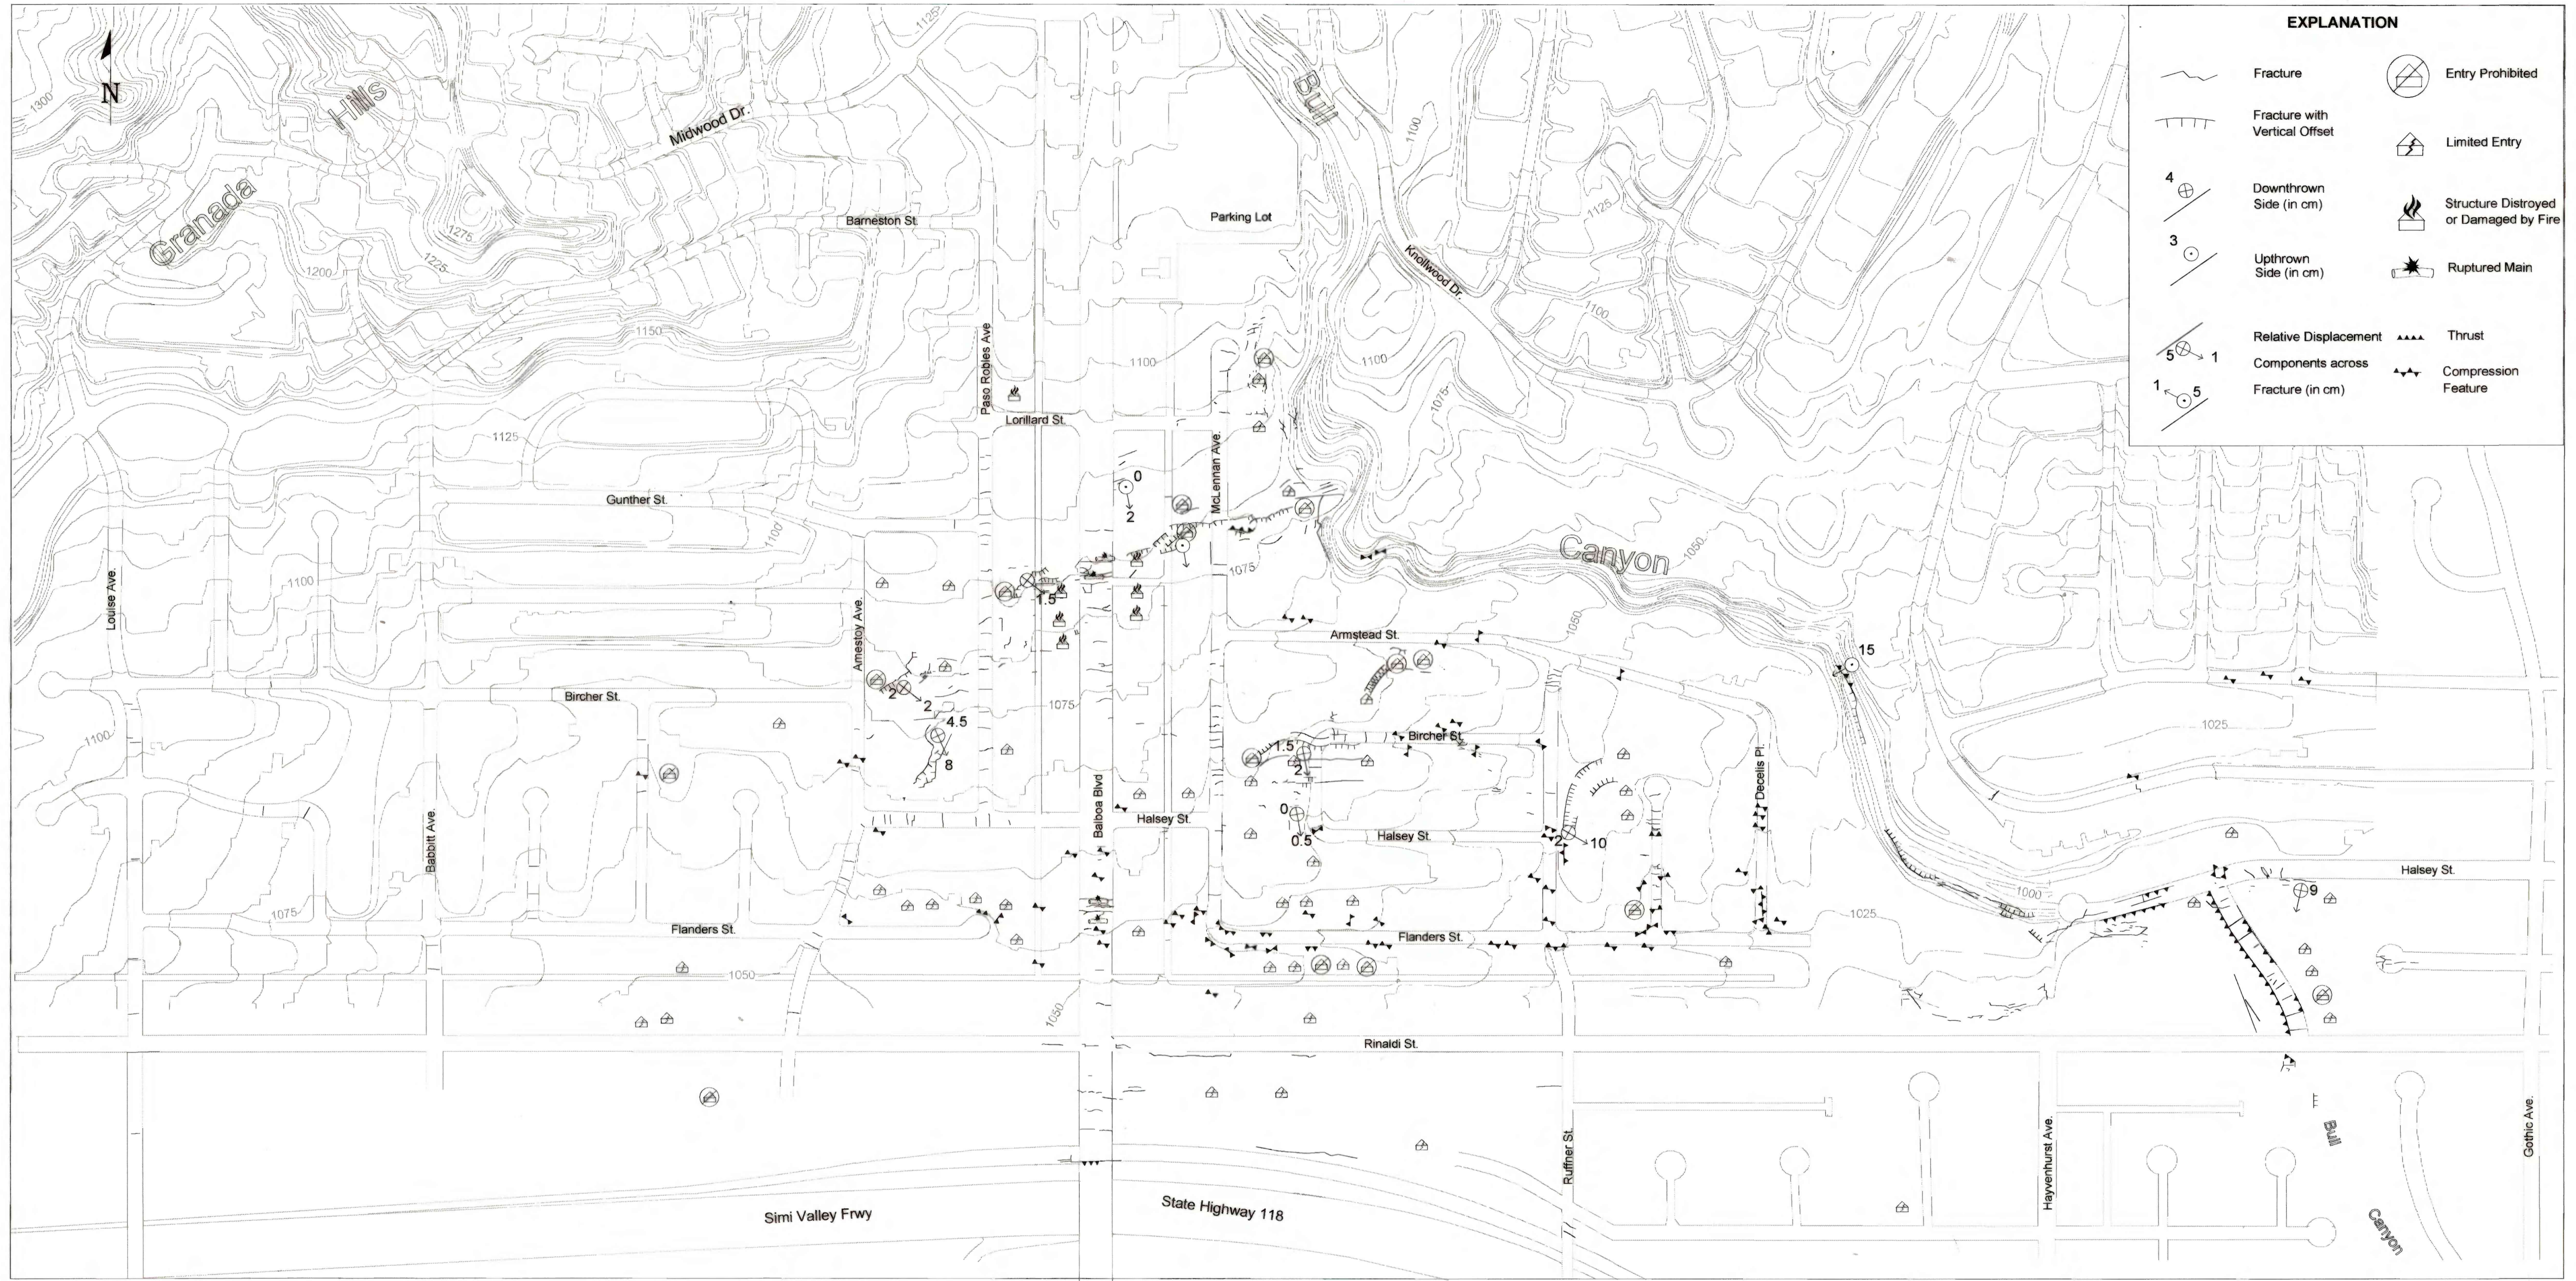
Base from City of Los Angeles, 1:1200, Topographic Map No. M-611, Sheets 78 and 79, 1970.
Most fractures shown here are simplified from Map by
S. Hecker, D.J. Poni, C.D. Garvin, T.J. Powers, T.E. Fumal, J.C. Hamilton
R.V. Sharp, M.J. Rymer, C.S. Prentice and F.R. Cinti
U.S. Geological Survey Open File Report 96-52.
Some added by Kenneth M. Cruikshank
